Lead-free Solders for High-Reliability Applications: High-Cycle Fatigue Studies

A thesis submitted to  
The University of Birmingham  
for the degree of  
DOCTOR OF ENGINEERING

Department of Metallurgy and Materials  
School of Engineering  
The University of Birmingham  
23 October 2008

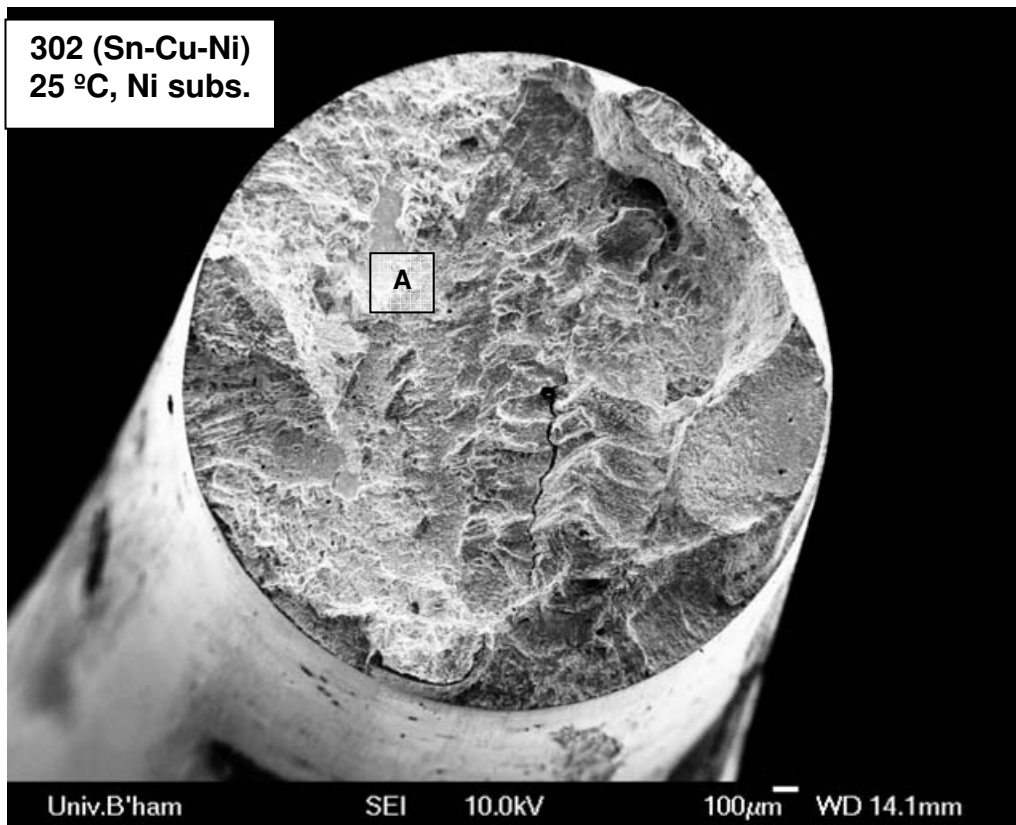
Figure 4.79. Secondary electron micrograph of Sn-Cu-Ni HCF fracture surface (tested at 25 °C, Ni substrate) showing fracture through bulk solder with no obvious initiation point
